**Flood Control Project Maintenance
Levee Inspections**
LMA District Cover Sheet
Spring 2010 Levee Inspection Results

Reclamation District No. 0536 Egbert

Levee Inspection Report By Mile - Spring 2010

Waterway						Bank	Unit Miles	Inspection Start/End	Inspector
Unit No. 01 Lindsey Slough						Right	5.66	05/06/2010 05/06/2010	Herman Phillips

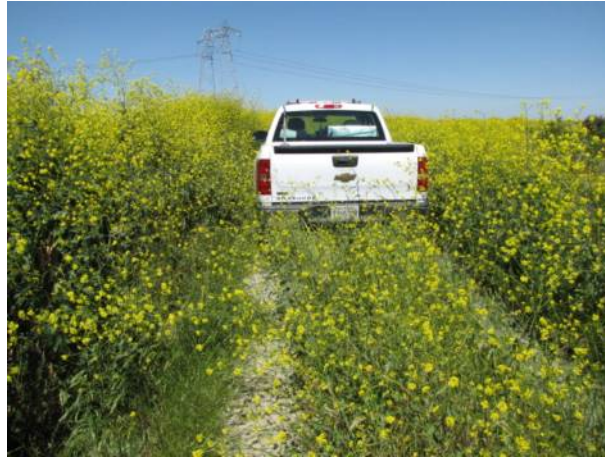
phillips_s_20100617_082.jpg

Levee Mile Report Line	2
Start Levee Mile	3.77
End Levee Mile	3.92
Location	Land Side
Category	Earthen Levee
Item	Vegetation

Looking upstream while standing downstream at levee mile 3.77 the weeds are taller than the vehicle.

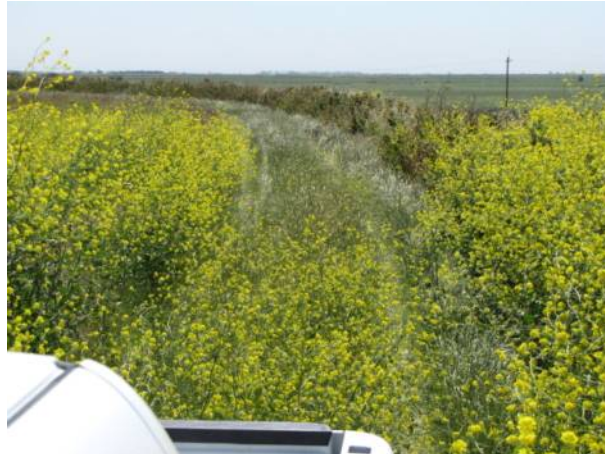
phillips_s_20100617_083.jpg

Levee Mile Report Line	2
Start Levee Mile	3.77
End Levee Mile	3.92
Location	Land Side
Category	Earthen Levee
Item	Vegetation

Looking downstream from levee mile 3.77.

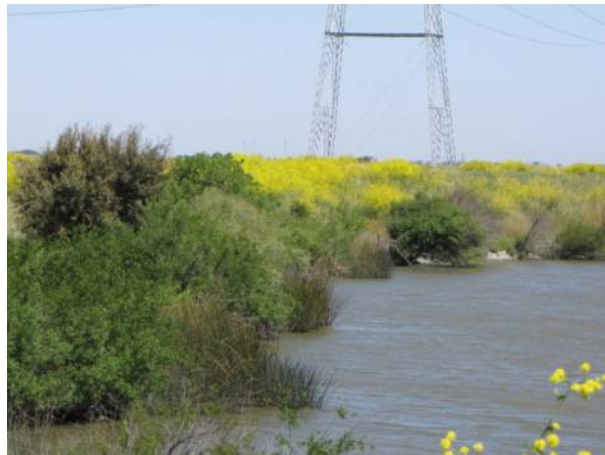
phillips_s_20100617_084.jpg

Levee Mile Report Line	2
Start Levee Mile	3.77
End Levee Mile	3.92
Location	Land Side
Category	Earthen Levee
Item	Vegetation

This photo shows the growth extends from shoulder to toe of levee looking back upstream.

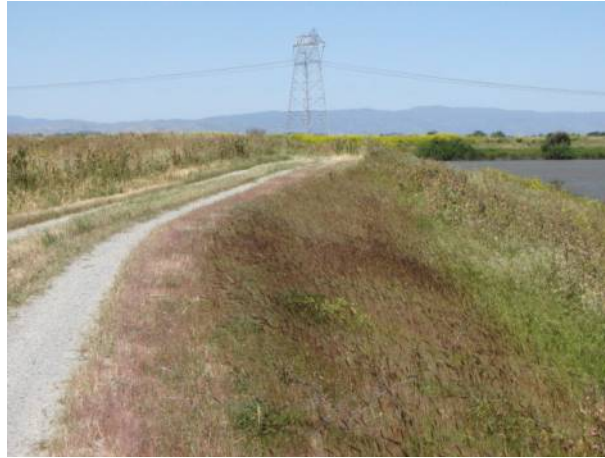
phillips_s_20100617_085.jpg

Levee Mile Report Line	3
Start Levee Mile	4.19
End Levee Mile	4.26
Location	Water Side
Category	Earthen Levee
Item	Vegetation

Looking upstream from levee mile 4.21.

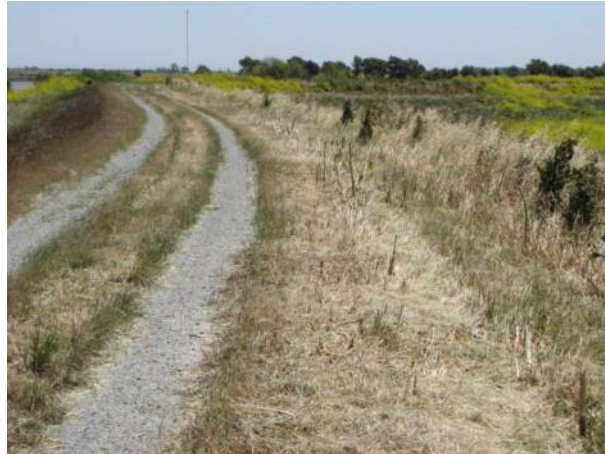
phillips_s_20100617_086.jpg

Levee Mile Report Line	3
Start Levee Mile	4.19
End Levee Mile	4.26
Location	Water Side
Category	Earthen Levee
Item	Vegetation

Looking downstream from levee mile 4.21

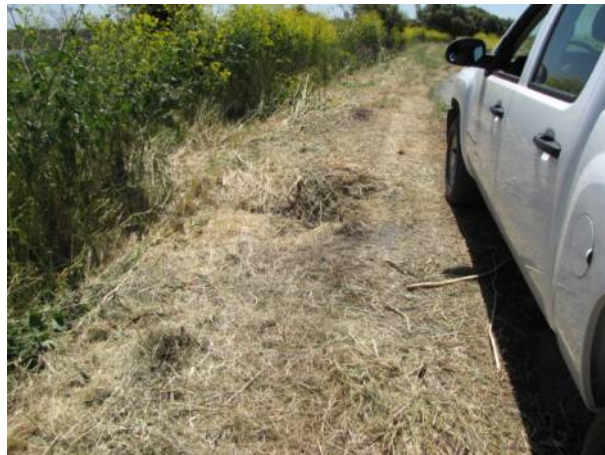
phillips_s_20100617_087.jpg

Levee Mile Report Line	12
Start Levee Mile	4.82
End Levee Mile	4.82
Location	Crown
Category	Earthen Levee
Item	Crown Surface / Depressions / Rutting

There is a big hole in the levee waterward.
38.248375 to -121.712188 the levee has wild
growth on both slopes.

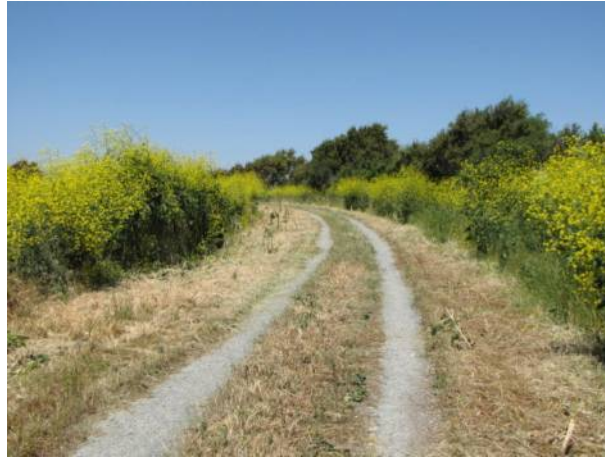
phillips_s_20100617_088.jpg

Levee Mile Report Line	13
Start Levee Mile	4.82
End Levee Mile	5.15
Location	Land Side
Category	Earthen Levee
Item	Vegetation

The District has mowed a pathway down the crown road way and both landward and waterward shoulders, weeds beyond there are 4-5-foot tall.

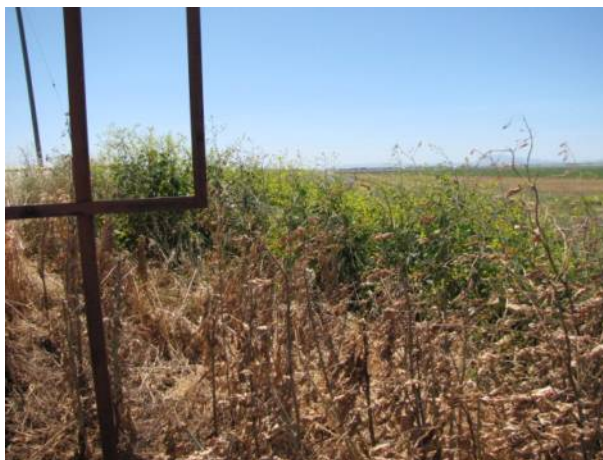
Levee Mile Report Line	1
Start Levee Mile	0.00
End Levee Mile	0.00
Location	Land Side
Category	Earthen Levee
Item	Vegetation
This photo shows the tall weeds on land side looking downstream from levee mile 0.00	
phillips_s_20100617_090.jpg

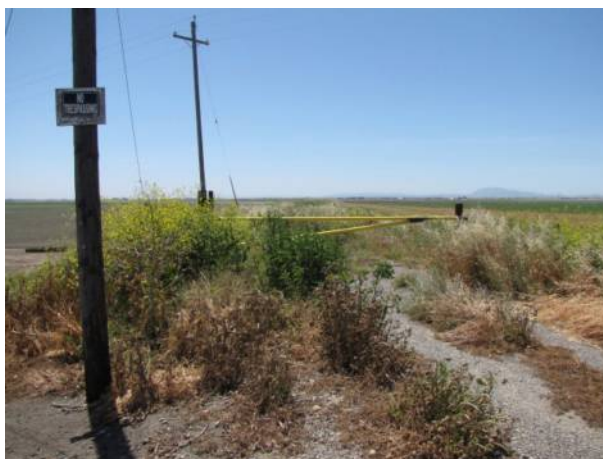
Levee Mile Report Line	1
Start Levee Mile	0.00
End Levee Mile	0.00
Location	Land Side
Category	Earthen Levee
Item	Vegetation
Standing on the waterward slope looking downstream at unit 2 RD 536 WEED GROWTH CONTINUES DOWNSTREAM.	
phillips_s_20100617_091.jpg

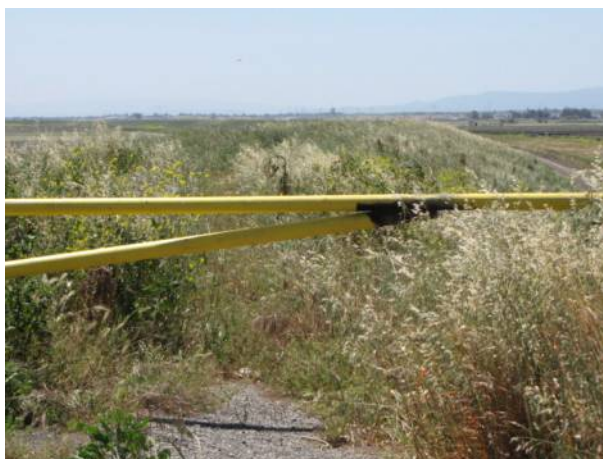
Levee Mile Report Line	2
Start Levee Mile	0.02
End Levee Mile	1.07
Location	Crown
Category	Earthen Levee
Item	Vegetation
Looking downstream of RD 536 unit 2 from levee mile 0.00 the weeds are 2-3 foot tall. This growth extends to levee mile 1.00	
phillips_s_20100617_089.jpg

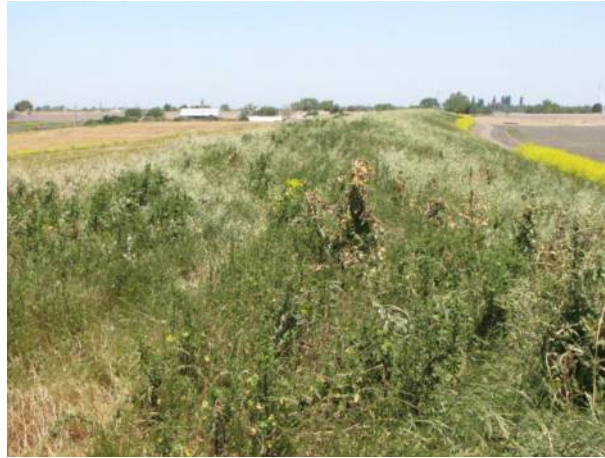
Levee Mile Report Line	2
Start Levee Mile	0.02
End Levee Mile	1.07
Location	Crown
Category	Earthen Levee
Item	Vegetation
Standing on crown road way looking upstream from levee mile 0.55 to 0.00.	
phillips_s_20100617_092.jpg
